**TAYLOR BROS. MARINE
CONSTRUCTION, INC.**

**Hull Repairs for USS North Carolina Battleship
Project
Submittal for the
The Pinnacle Awards
2011 Best Construction Project Competition**

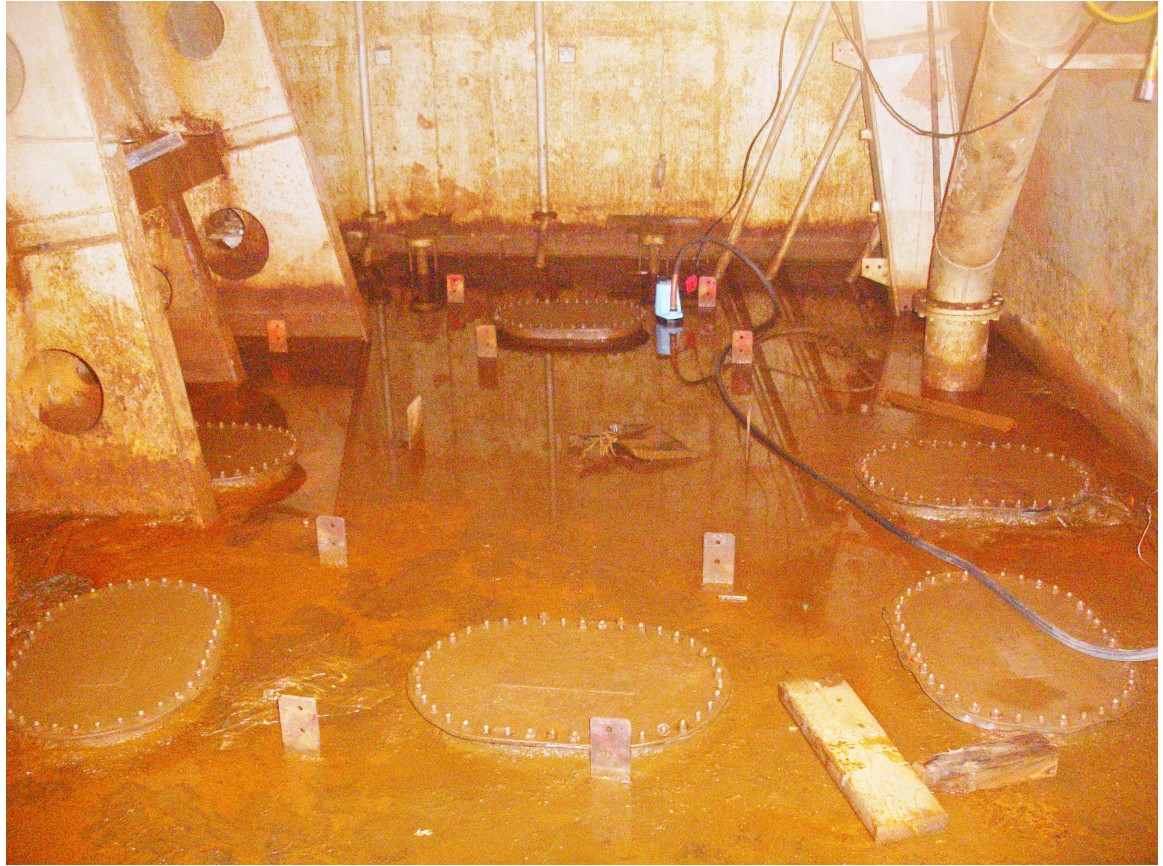
The Battleship North Carolina is berthed in a slip on the Cape Fear River, directly across from the city of Wilmington. The ship was ballasted down when she was placed in the slip and sits firmly on the bottom. This slip has filled in with silt and mud over the years and ebbs out completely at low tide for two thirds of the ship's length. Since the ship is on the bottom, the tide rises and falls on her hull without the ship floating with it. This results in a wet/dry cycle for a five foot tall band around the hull (5 foot range of tides). This wet/dry cycle has caused coating failure, and subsequent galvanic corrosion (pitting) of the exposed steel.

Fifty years after being berthed in Wilmington, the hull on the starboard bow suffered from major corrosion damage. The forward 135 feet of the ship is plated with 1/2" plate, which corroded through in several areas on the starboard bow just below the waterline (wind/waterline corrosion). The ship is built of much heavier plating and even armor aft of this point, and is in better condition. As seen in Figure 1, Typical Interior Conditions, the inside of the ship was suffering because of the breaches in the hull plating resulting in flooded compartments and accelerated deterioration.

Figure 1. Typical Conditions

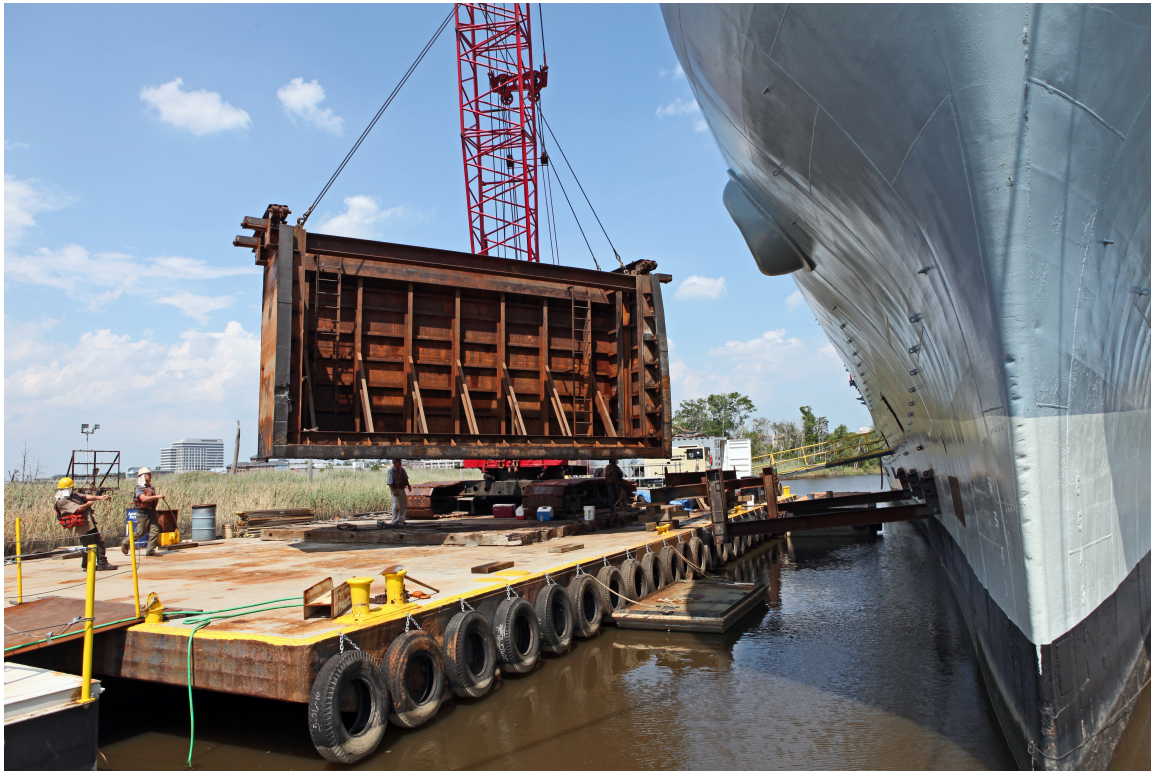
Taylor Bros. Marine designed the system to attach the cofferdam to the hull (hinge plates), and the system to move the cofferdam from the edge of the barge out to the hull (transfer system). The transfer system was necessary because the rake (overhang) of the ship's bow prevented the crane from directly placing the cofferdam on the side of the ship. See Figure 2, Cofferdam Installation.

Figure 2. Cofferdam Installation

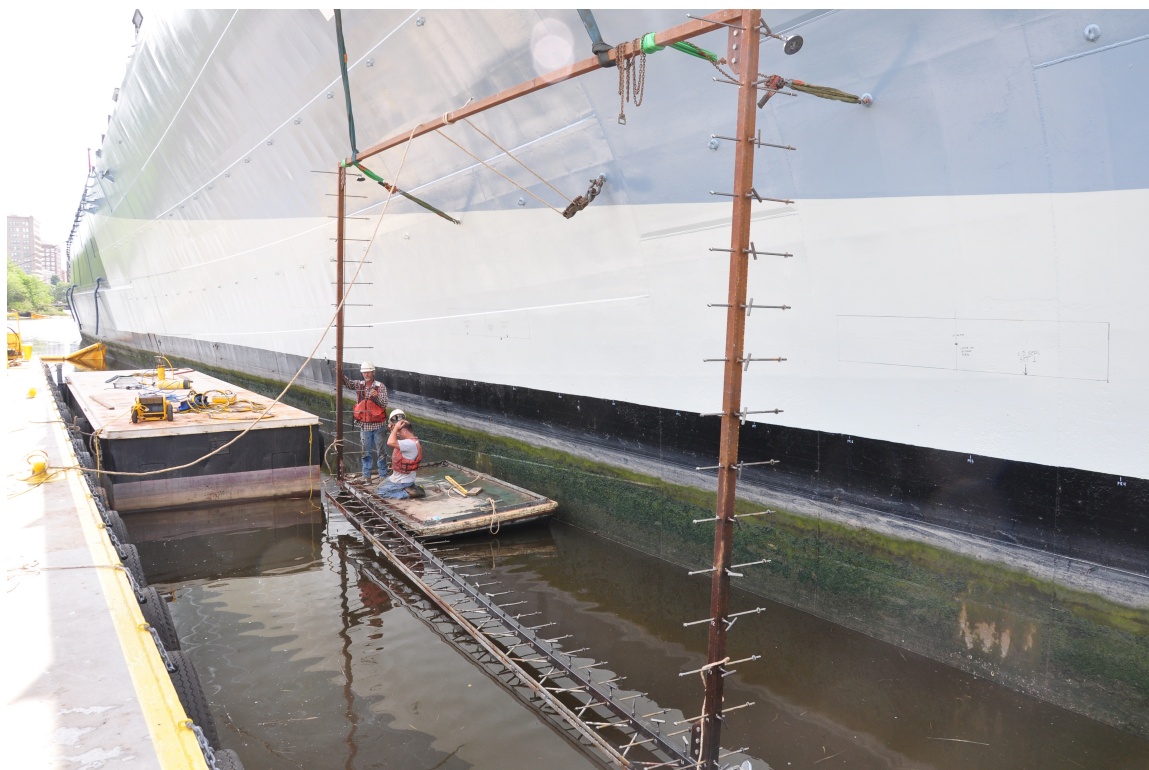
Once the cofferdam was in place and a system was set up to access the site, Taylor Bros. Marine was ready to go to work. The next phase of the project was to create a system to map the curvature of the hull, and create seals for the cofferdam. The shape of the sealing surface of the cofferdam was critical to ensure minimal leakage while cutting into the hull at depths of up to 12 feet underwater. A hull gage was designed and fabricated and then used to measure and record the profile of the existing hull at each planned cofferdam set location. The gage consisted of a square tubing frame that measured 15' tall by 30' long (same dimensions as cofferdam sealing surfaces). A lockable pin was installed every 12" along the frame. See Figure 4, Hull Gage. The frame was held into position about 3 feet off of the hull using strong magnets on jackscrews at each corner of the gage. Once the gage was in position, the jackscrews were adjusted to ensure that the gage was exactly plumb and level. A diver then positioned each pin against the hull, and locked it into place. Once all pins were locked, the gage was removed, and each pin measured and recorded.

Figure 4. Hull Gage

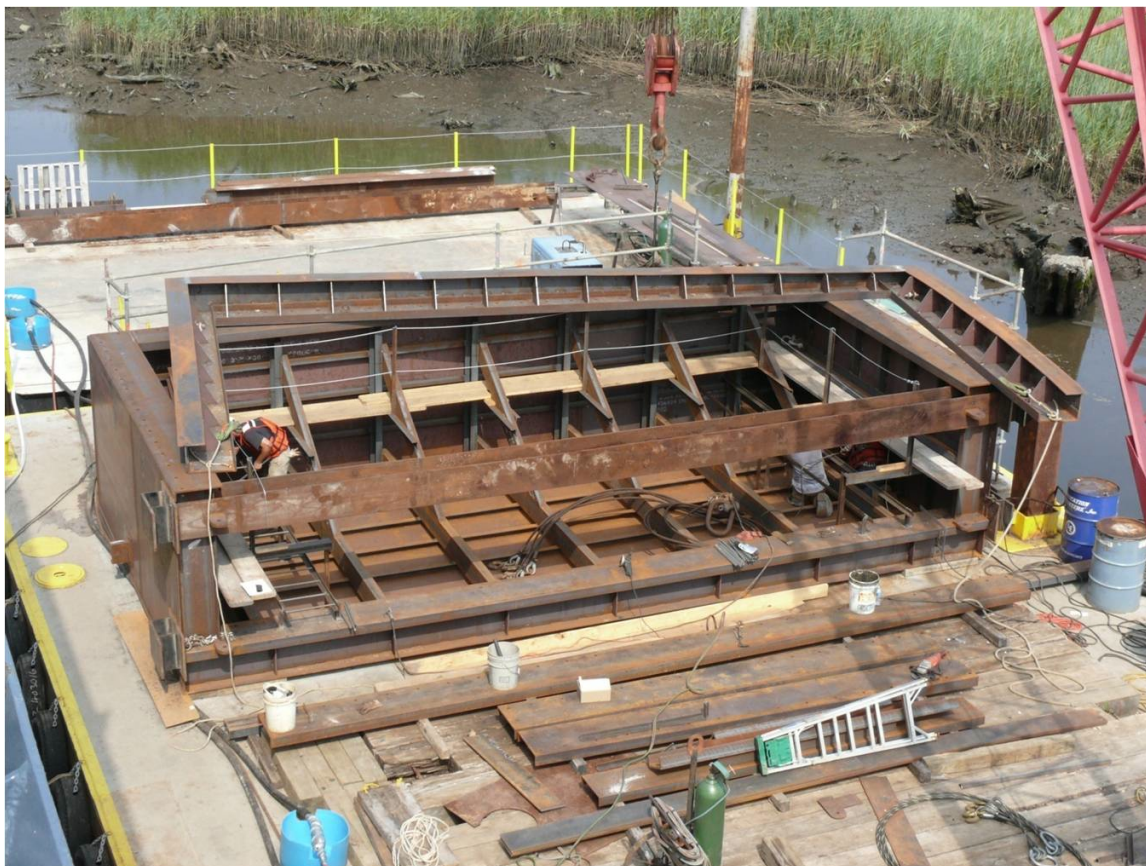
This created an exact contour of the hull every 12" along the cofferdam seal. The open end of the cofferdam mating with the hull was fitted with a large flange. The removable flange face was fitted with 1/2" thick, framed plate. This plate was marked every 12" with the hull gage data, faired, and trimmed with a torch. A 1/2" by 10" wide flat bar was welded to that cut edge to form the seal face. Finally, a 2" thick, by 10" wide piece of oil resistant foam insulation, very similar to that used on air conditioning lines, was glued to the seal face. See Figure 5, Cofferdam Flanged Seal Face.

Figure 5. Cofferdam Flanged Seal Face

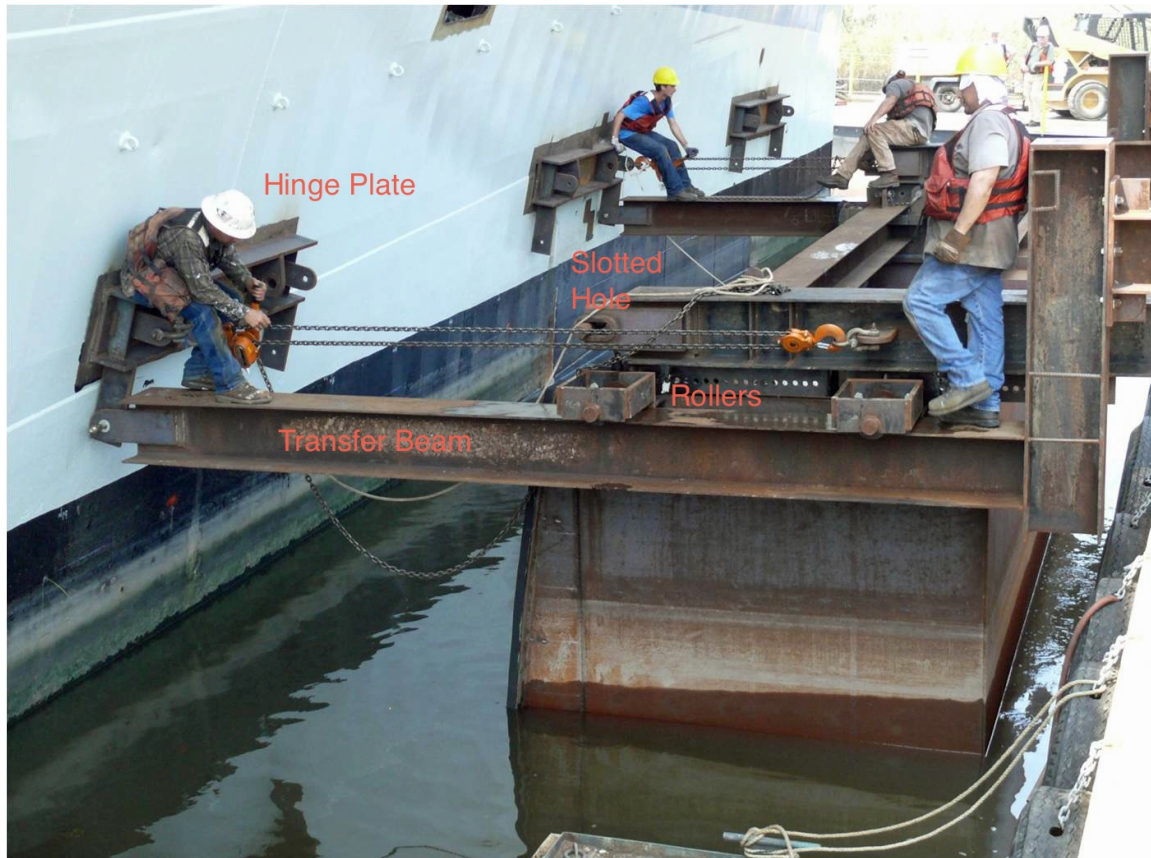
The transfer system was necessary to allow horizontal movement of the cofferdam from the edge of the work barge over to the hull. The rake of the bow, especially at the forward most end of the work area, prevented hanging the cofferdam immediately next to the hull. The transfer system consisted of two large beams extending from the deck of the barge to each hinge plate. Each hinge plate contained two extra pad eyes just for the transfer beam-ends. A cross beam also connected to the two free ends of the transfer ends to prevent the beams from spreading apart while the cofferdam was on the beams. The cofferdam was lowered onto the transfer beams and rested on four removable rollers. Once the cofferdam was resting on the beams, the lift crane was disconnected from the cofferdam, and connected to the transfer system cross beam. The cross beam was lifted with the lift crane to permit the face of the cofferdam to engage the hull squarely, or slightly top in with a gap at the bottom of the cofferdam. The rollers allowed the crew to roll the cofferdam into position relatively easy with large chain ratchets. Once the top of the cofferdam was against the hole, a large pin was inserted through two slotted holes in the cofferdam-handling rig, engaging the hinge plate large pad eye. This fixed the top of the cofferdam to the hull. The cross beam was lowered, and the cofferdam came to rest against the hull of the ship. The slotted hole was critical in the design and allowed the top of the cofferdam to move in and out to prevent binding while lowering the cross beam and seating the cofferdam. See Figure 6, Transfer System with Slotted Hole Visible. A large turnbuckle was attached at each top end of the cofferdam to draw in the top of the sealing surface and ensure that pressure was maintained on the top of the sealing surface at all times. The rollers and transfer system were then removed, and the cofferdam dewatered with a large pump.

Figure 6. Transfer System with Slotted Hole Visible

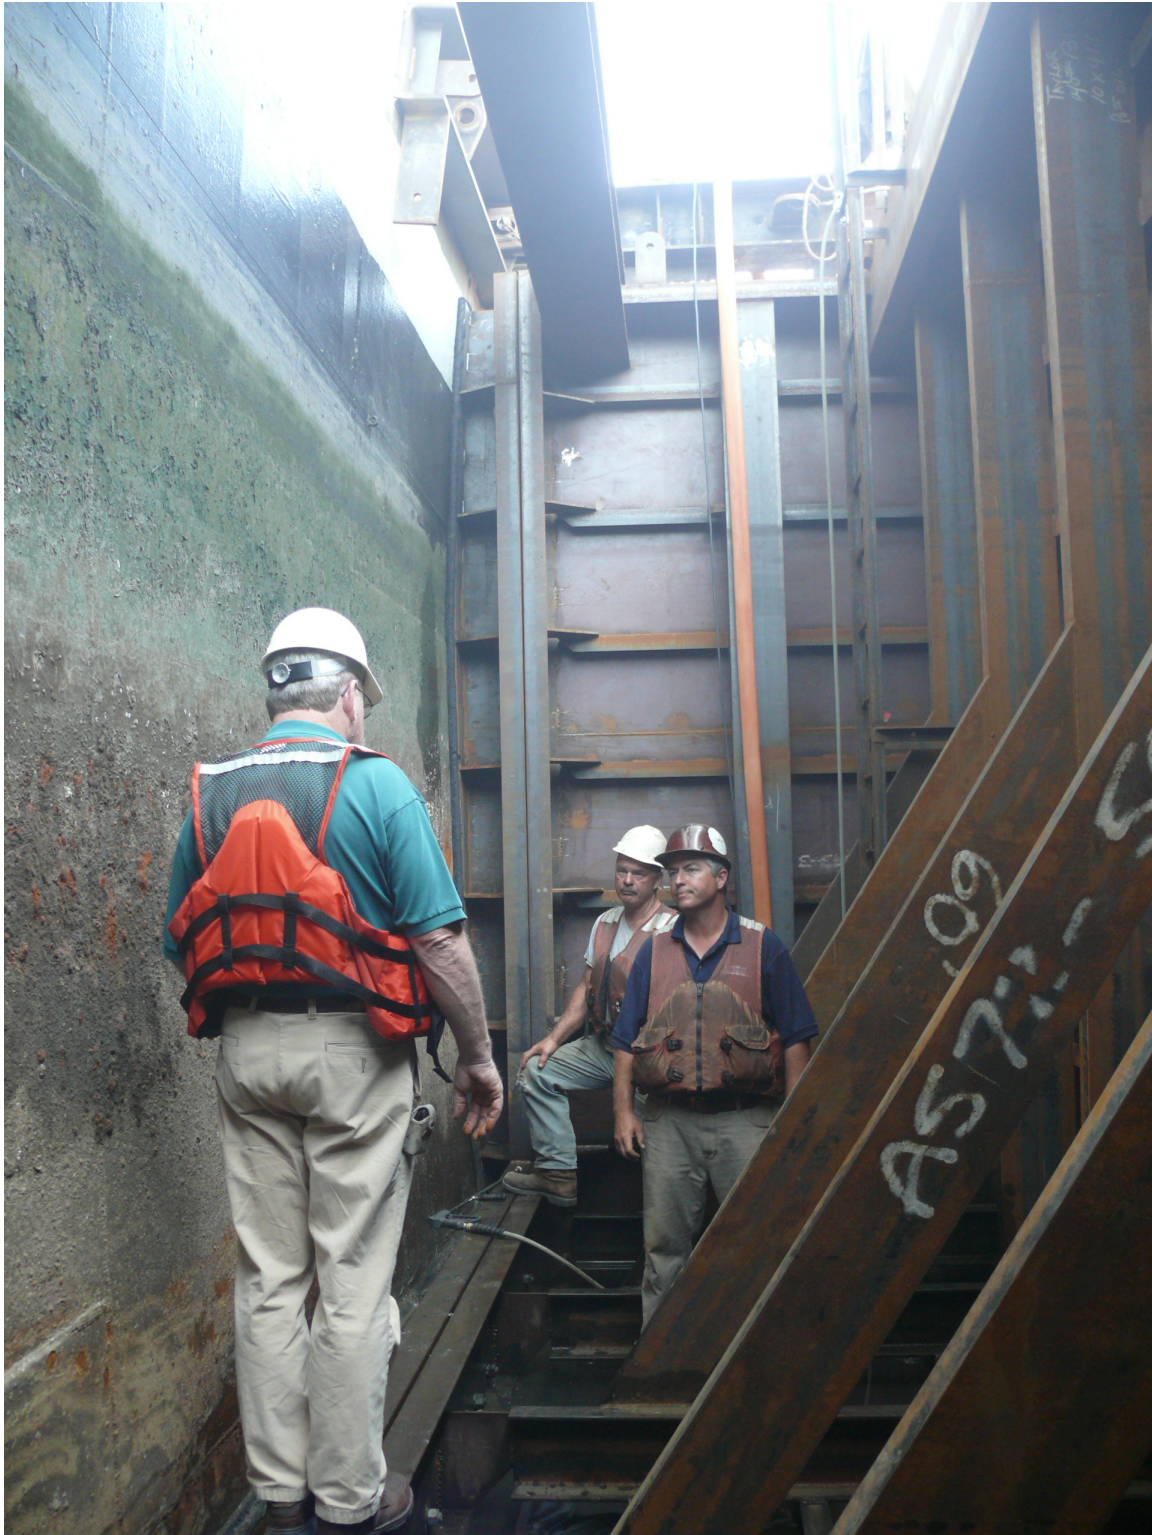
Taylor Bros. Marine was very concerned that the leakage rate would be excessive and that constant pumping would be required to maintain the cofferdam dry enough to work in. The first cofferdam set was made, and the cofferdam was seated very late in the day. The decision was made to send everyone home for rest and dewater the cofferdam the next day. One small electric garden hose sized pump was left in the cofferdam by mistake when the crew left that night. We came in the next morning to find one burned up garden hose pump, and a completely dry cofferdam. The leakage rate was zero, and conditions actually got dusty in the cofferdam later that day. The system worked far better than imagined. See Figure 7, Looking at the Hull For the First Time in 50 Years.

Figure 7. Looking at the Hull for the First Time in 50 Years

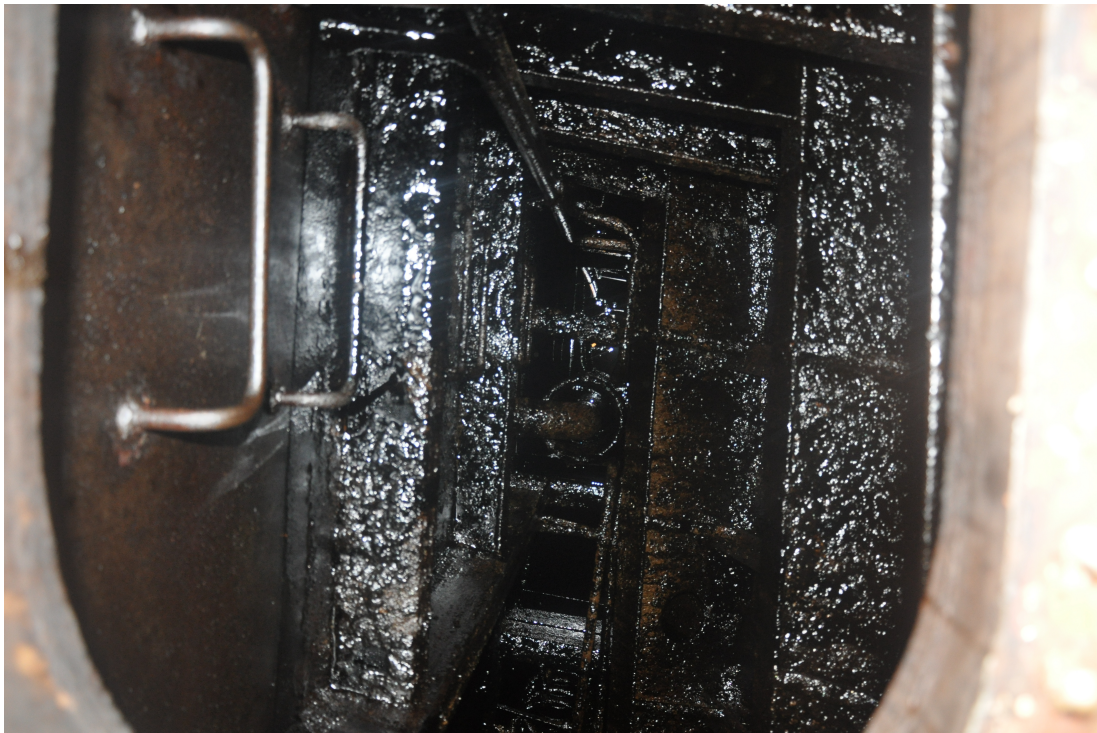
Cofferdam work and lead based paint remediation was started at the forward end of the 132-foot work area. The aft 80 feet of work included cutting into 4 of the ships fuel tanks, therefore a crew commenced cleaning those tanks, and the 4 adjacent tanks once the access system was set up. Tank cleaning consisted of accessing each tank, pumping all of the existing fuel to a tank on shore, then spraying the interior of the tank with diesel fuel. The diesel was pumped out, and more sprayed in until the tank walls and structure were clean enough to wipe clean with towels. This usually took three or four iterations of diesel spraying to clean a tank, and it was arduous work. Once the tank was cleaned, a forced ventilation system was set up in each tank to clear harmful and flammable gases and maintain the atmosphere safe for entry and for hot work. The plan was for the tank cleaning to be complete prior to the cofferdam and work area reaching the fuel tanks, and that developed as planned. See Figure 8, Fuel Tank Prior to Cleaning. As seen in this photo, cleaning the tank was no trivial task.

Figure 8. Fuel Tank Cleaning

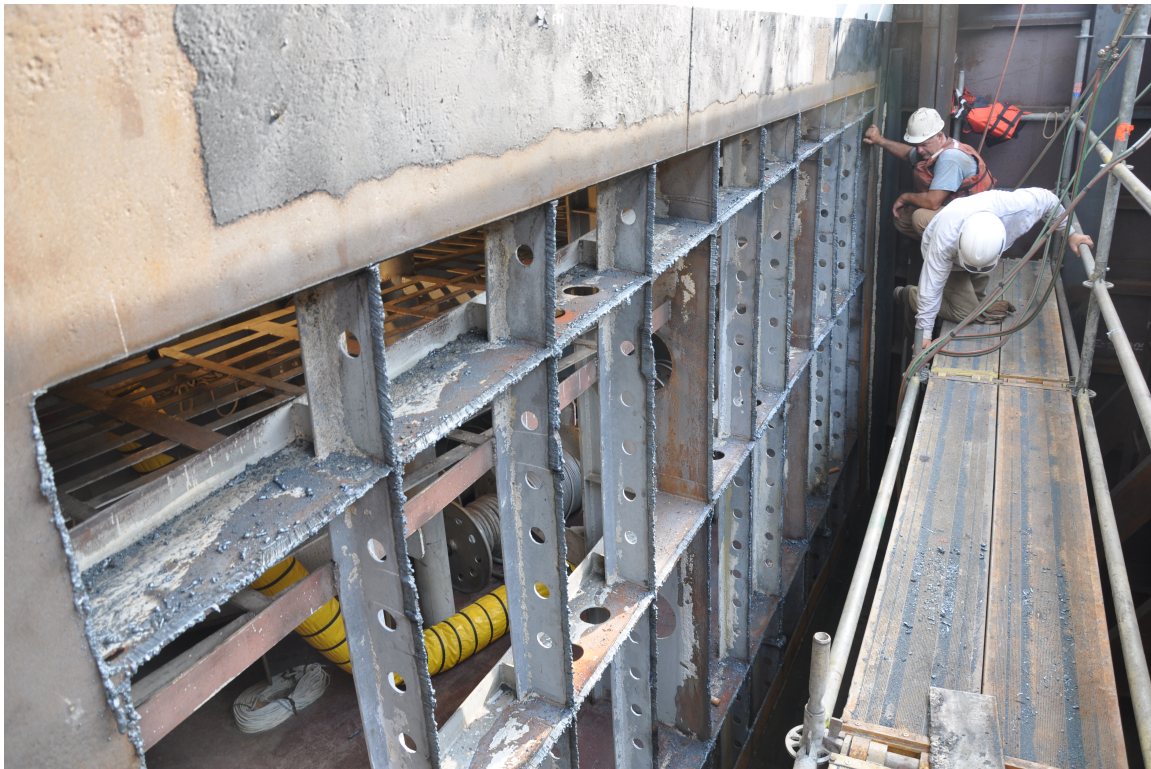
Once dewatered and remediated, the hull was inspected and the cut lines were marked for cut and removal. A track torch was used to make the cuts straight and beveled, which saved time when new plate was fit in. Once the outer boundary cut was made, each section between frames within that boundary was cut out and removed. See Figure 9, Hull Plating Removed. Inspection of this photograph makes it obvious why the cofferdam leakage rate was so important.

Figure 9. Hull Plating Removed

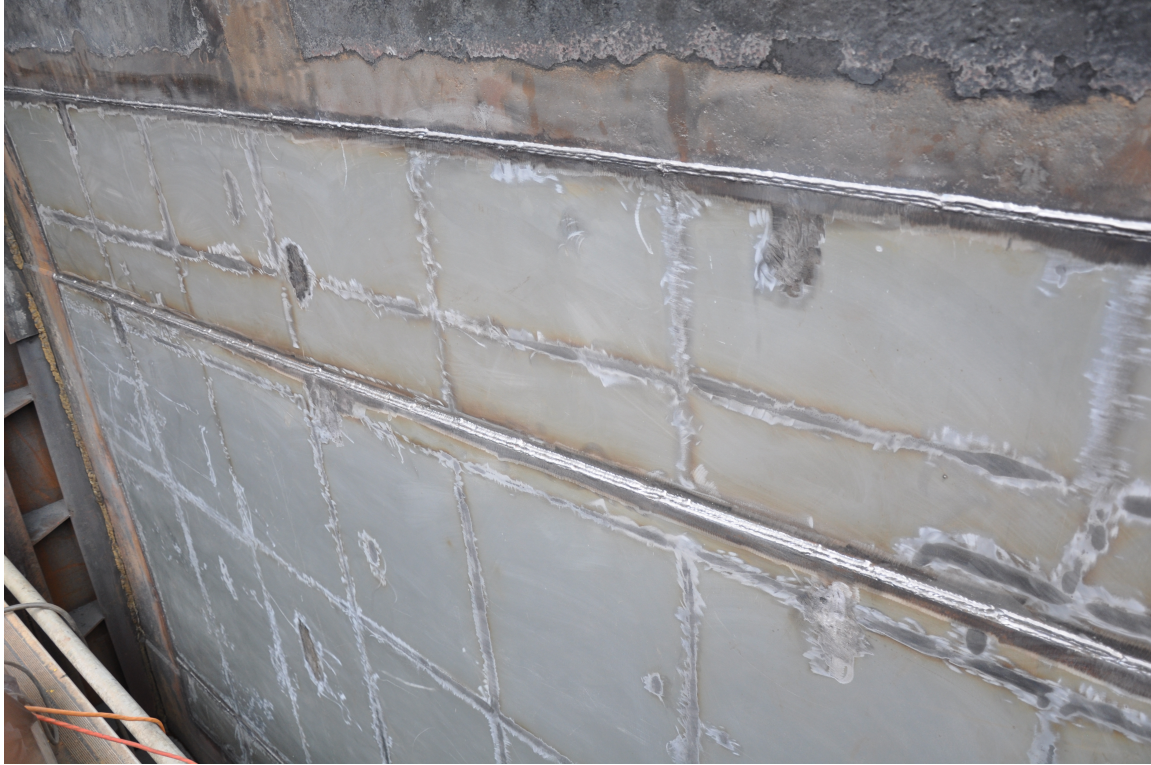
Figure 10. New Plating Installed

The remaining framing was cleaned up and prepared for welding in the new plate. Taylor Bros. Marine had the new plate shop-blasted and coated with the specified primer prior to arrival, which saved more time. The new plate was cut, fit and dogged into place, and welded out. See Figure 10, New Plating Installed. As seen in this photograph, the original plate lapping lines were maintained when the new plating was installed.

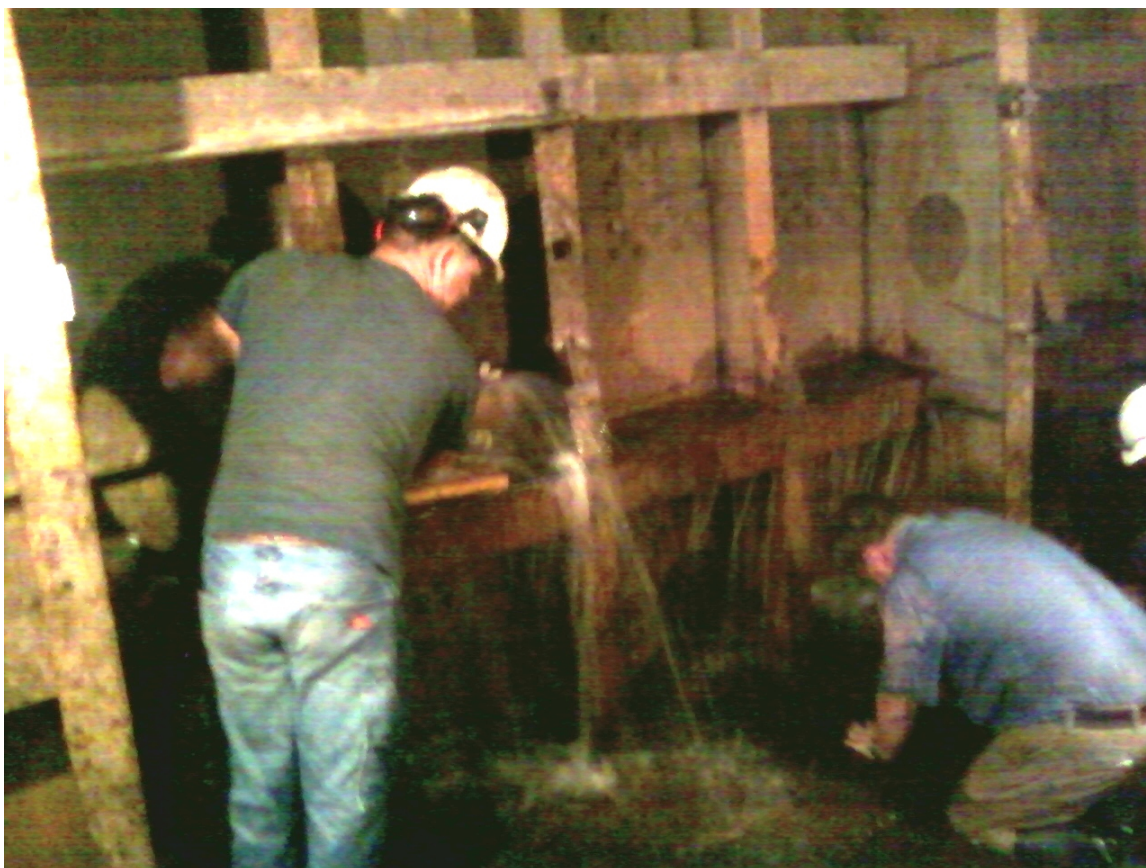
Another unique risk faced was the constant threat of new leaks forming in the areas not yet repaired. This became a serious problem once the fuel tanks were cleaned and opened. Special patches were made and staged in likely leak areas. The patches could be attached by lowering them down on the side of the ship with a pole. A bolt was passed through the leak, and the patch tightened to the hull from inside the ship. This patch method was used 6 times prior to replacing the corroded hull in the after sections. See Figure 11, Patching a New Leak.

Figure 11. Patching a New Leak

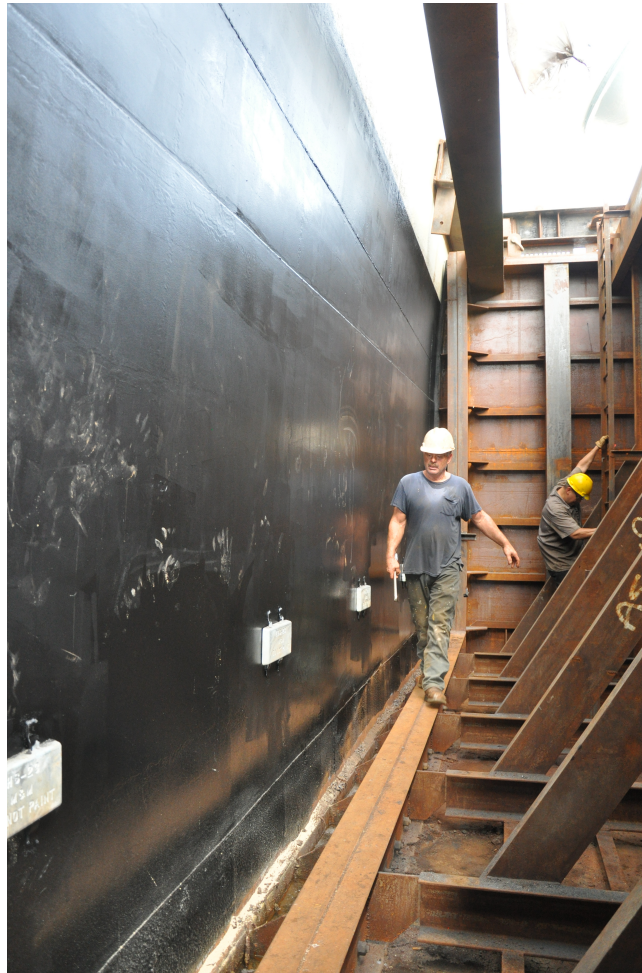
Figure 12. Final Exterior Product with Zinc Anodes

the tanks for the subsequent repair work. These new leaks threatened to flood the open fuel tanks, which would have been extremely expensive to dispose of the water that would have flooded the tanks. A change order was accepted to apply a high strength epoxy coating to the inside of the hull, and no more leaks occurred. The third and final change order was issued to cut out and remove the interconnecting steam heating coils inside of the fuel tanks to prevent water in those tubes from migrating from tank to tank. All of the change orders totaled to about \$13,500.00 and kept the project well under budget. See Figure 12, Final External Product with Zinc Anodes.

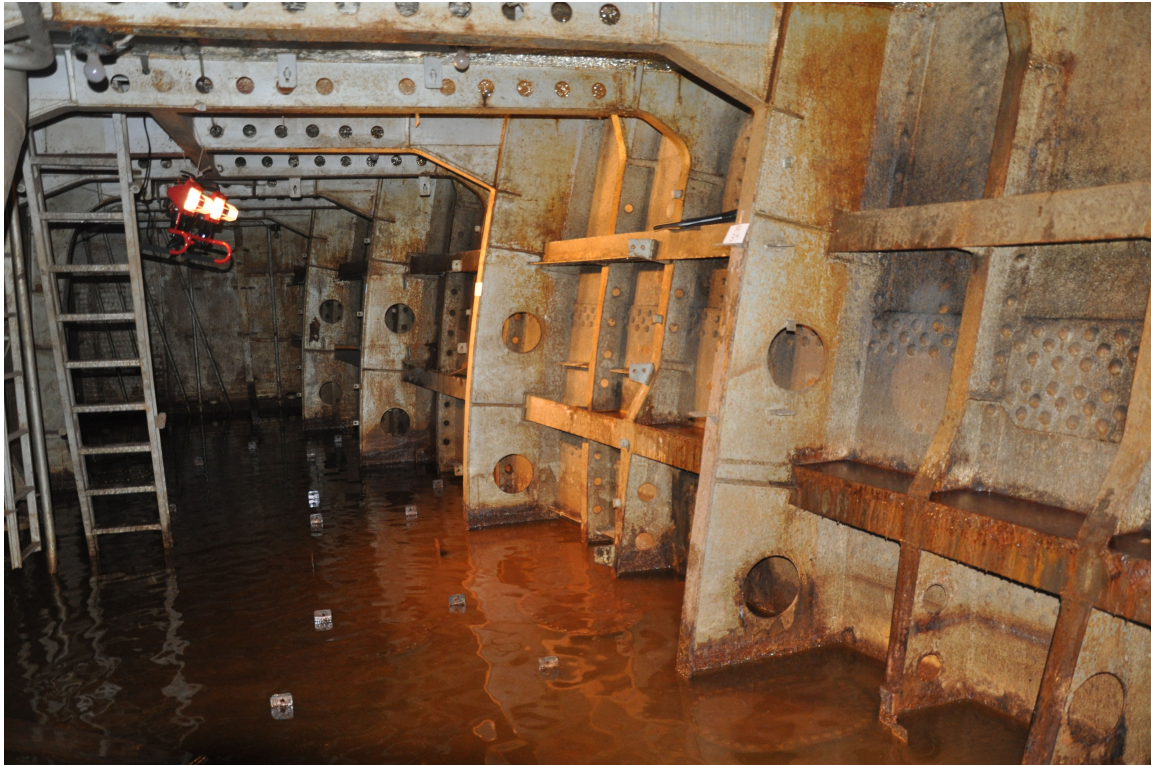
Figure 13. Compartment A-405-A Existing Condition

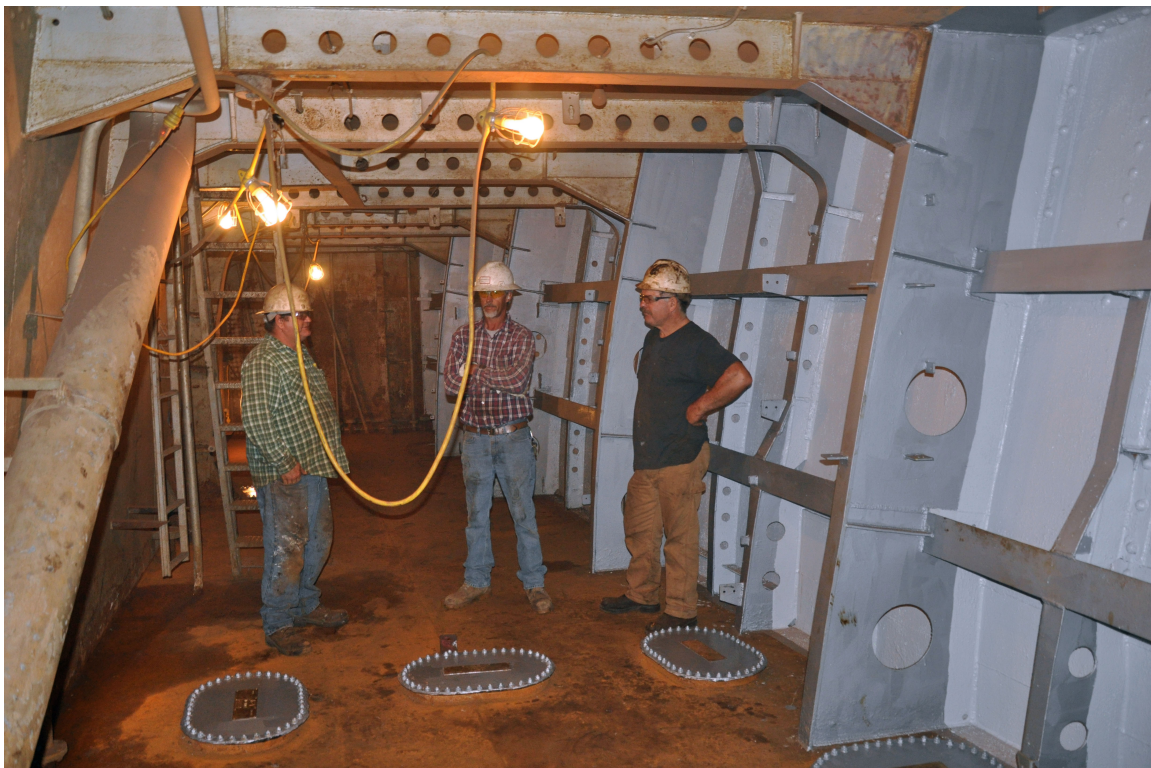
Figure 14. Compartment A-405-A Post Repairs
