# **Progress Energy Southport Nuclear Power Plant Diversion Structure Stabilization Project**

**Pile Driving Contractors Association (PDCA)**

**2010 Project of the Year**

**Submitted by: Taylor Bros. Marine Construction, Inc.**

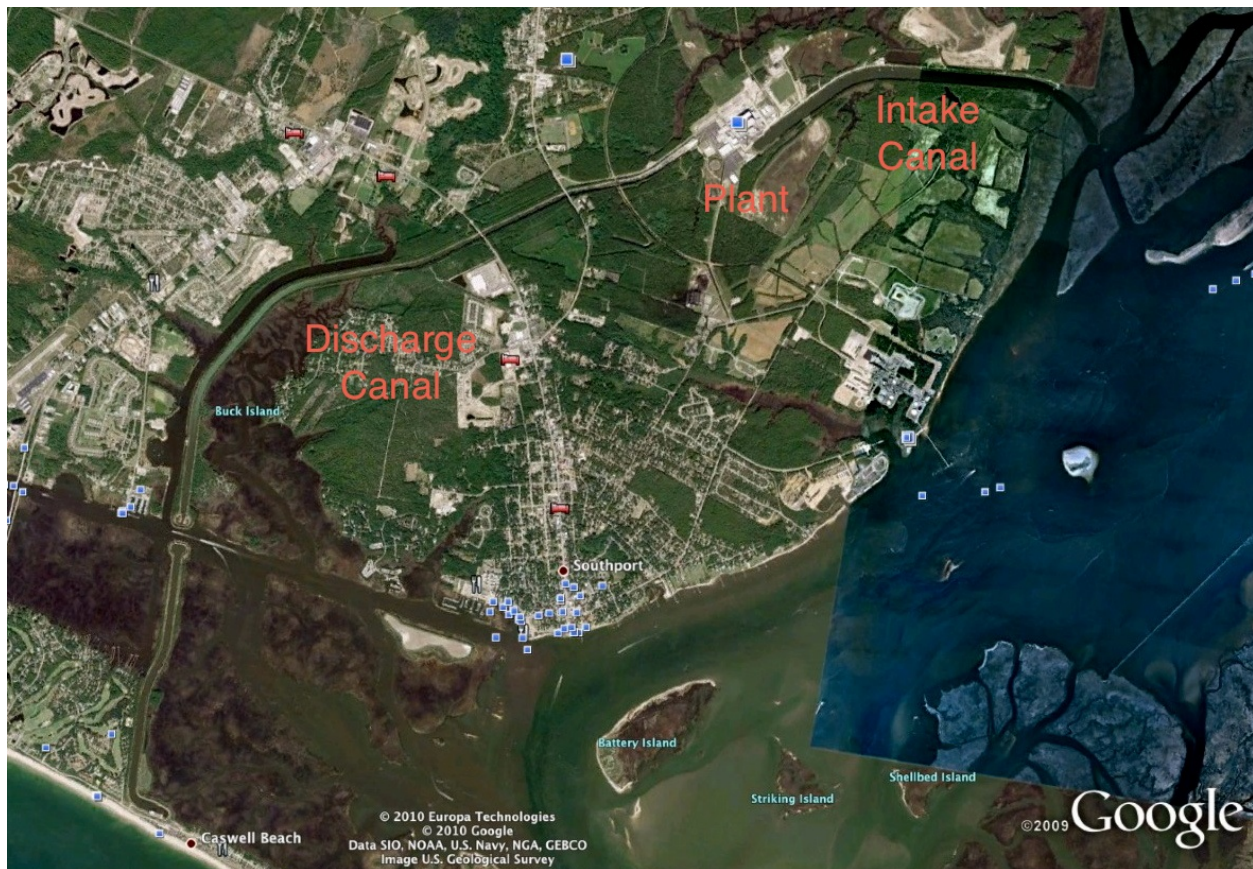
**Figure 1.** Progress Energy Nuclear Power Plant Coolant Flow Canals

The Progress Energy Nuclear Power Plant is located in Southport, NC and consists of two General Electric Boiling Water nuclear reactor generating stations. Due to its unique location near the Cape Fear River and the Atlantic Ocean, the plant draws its cooling water in from the Cape Fear River where it flows approximately 2 miles down a man-made canal. Once the water is used as coolant for the steam turbine condensers, it is discharged from the plant to the Atlantic Ocean via a 5.5-mile man-made canal, passing through a massive tunnel underneath the Intracoastal Waterway (Figure 1). As seen in this satellite photograph, the plant is massive, and is a significant engineering and construction achievement.

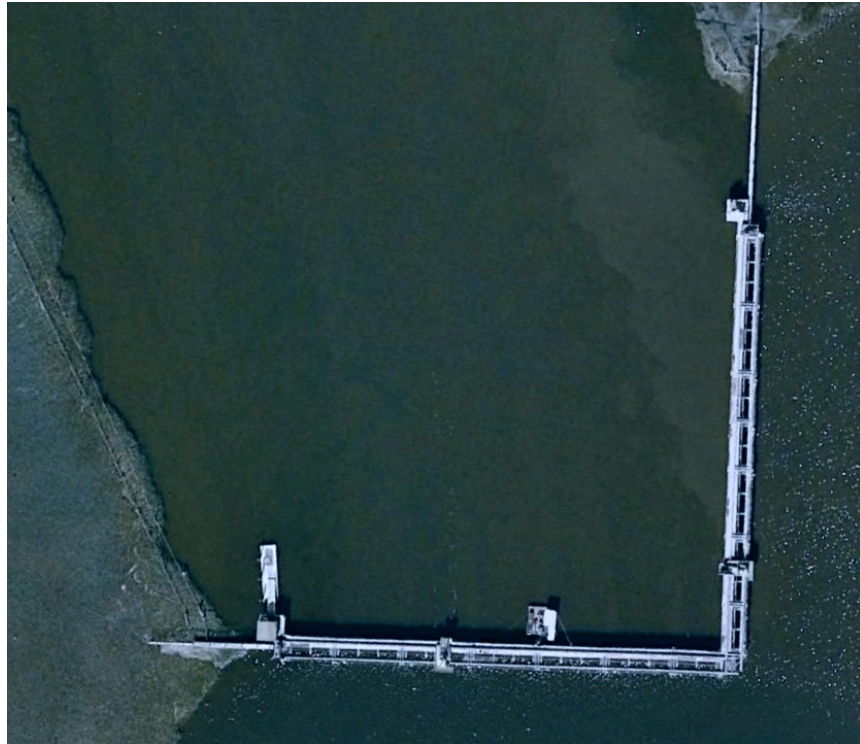
**Figure 2.** The Diversion Structure

To prevent marine life such as fish and turtles, along with marine sea grass from entering the plant, a large Diversion Structure was built at the inlet of the Intake Canal. This 30-year old structure is V-shaped, with the annex facing the Cape Fear River at the center of the structure (Figure 2).

It consists of 2 end pile bents and 13 interior bents. Each bent is made up of four 24-inch square concrete piles with an imbedded H-Pile stinger in the end for driving. The tips of the piles are located at approximately -40 feet mean sea level with pile the stingers protruding an additional 10 feet into the bottom. A wire mesh screen and turtle excluder is maintained between each bent, and can be raised for cleaning by each of two special cleaning rigs on each leg of the structure (Figure 3).

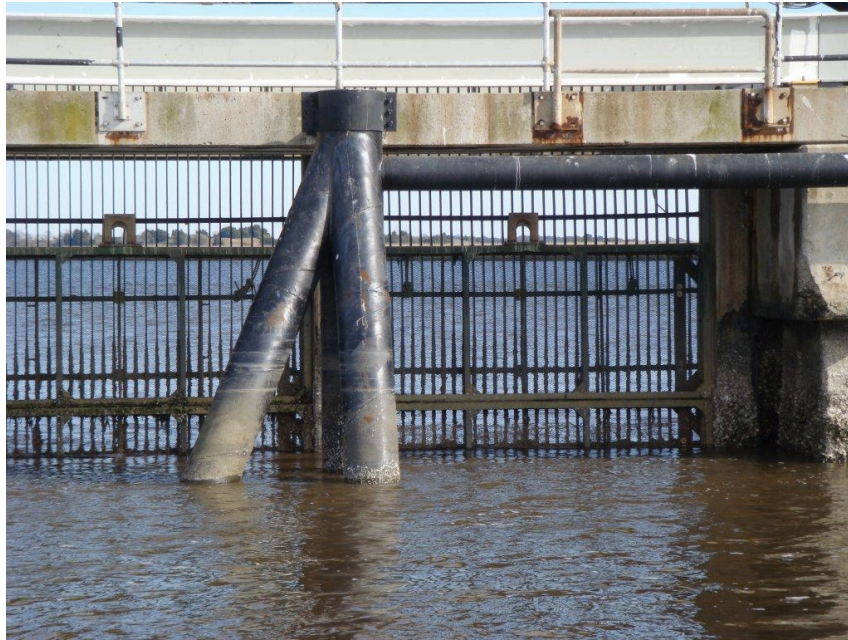
**Figure 3.** Diversion Screen and Turtle Excluder

The screens rest on a seat beam affixed to the top of sheet pile extending to the bottom approximately 20 feet down from the surface of the water. With both reactor plants online drawing cooling water, and depending on the tidal level, there can be up to 3 feet of differential head on each of the screens. This differential pressure (DP) is felt for the entire vertical length of each screen, resulting in very large forces applied to the structure during high DP conditions. Of note, hurricanes and tropical storms can produce unusually high tides, which further increase the DP imposed on the structure. As a result of recent storms last decade, two of the structure bents have moved inward (away from the Cape Fear River) with a maximum deflection of 9-3/4". If left uncorrected, this condition would further worsen, forcing the plant to be shutdown pending repairs.

Progress Energy contracted a well-known and reputable engineering firm to design a corrective system of driven piles to shore up the structure and prevent further movement. Taylor Bros. Marine Construction, Inc. (TBM) was contracted by Progress Energy to drive two test piles, and perform the subsequent installation of the driven pile system.

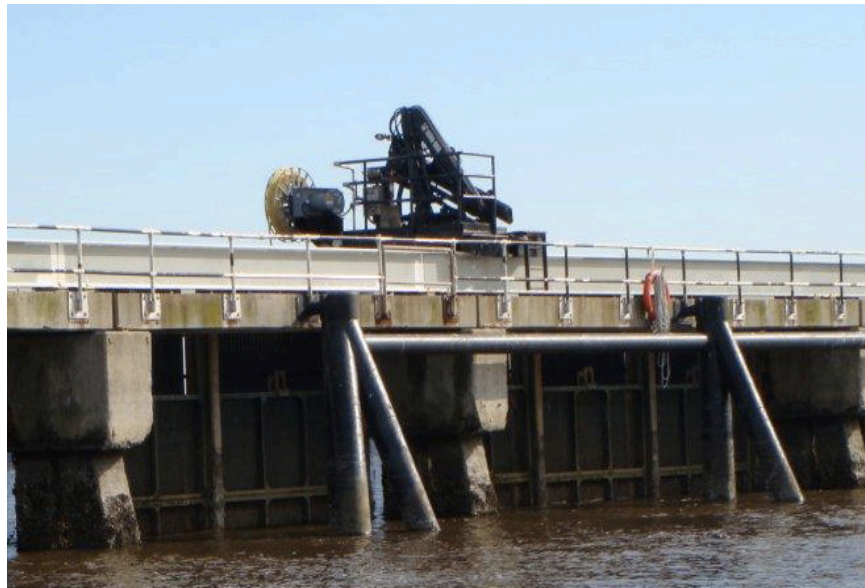
**Figure 4.** Rail-mounted Cleaning Machine

**Coordination and Efficiency:** The most significant known challenge at project start was the required coordination between the pile driving crew and the diversion structure maintenance crew. The mesh screens must be cleaned daily (sometimes more often) due to heavy build up of sea grass and river debris. Each of the two legs of the structure has a rail-mounted cleaning machine that lifts the screens, then diverts the debris to a collection chute as it is manually removed (Figure 4). Since all of the driven piles were in close proximity to the structure, and the batter piles actually pass over the structure before driving to grade, very close coordination was required to prevent shutting down the structure. If the structure became “clogged” and prevented sufficient cooling water intake, one reactor plant would be shutdown until the problem could be corrected. If the structure became further fouled, the second reactor plant would be forced to shutdown as well. The delay charges for shutting down each reactor plant approach approximately \$ 1 Million per day, per plant.

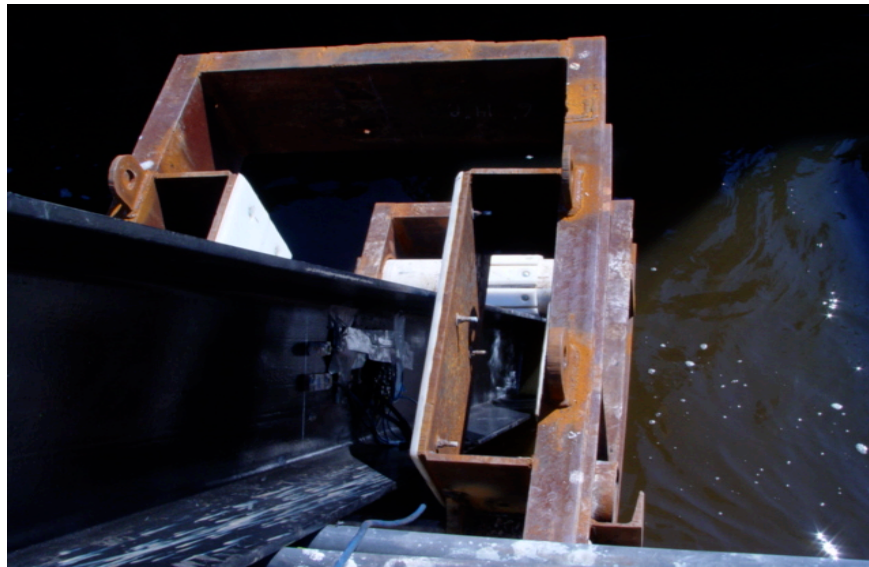
**Figure 5.** Template Utilizing Connection Studs

To mitigate the risk of shutting down a plant, which would completely eliminate all profit and fun for the job in an hour or so, a very efficient pile driving system was needed. Once started, a pile had to be set and driven below the grade of the structure rail for the cleaning machines before the machine had to pass by that location. TBM designed and built a template that could be used for the vertical piles, and then rotated for the batter piles. It was bolted to the pile caps using the studs that were installed for the future pile connections to the structure (Figure 5). This enabled TBM to drive a vertical and batter pile at each bent with one template, with minimal setup between piles.

Also innovative was the bolt-on template utilizing the studs for the subsequent connection system. This created a precise guide for locating the job pile in the applicable hole or slot.

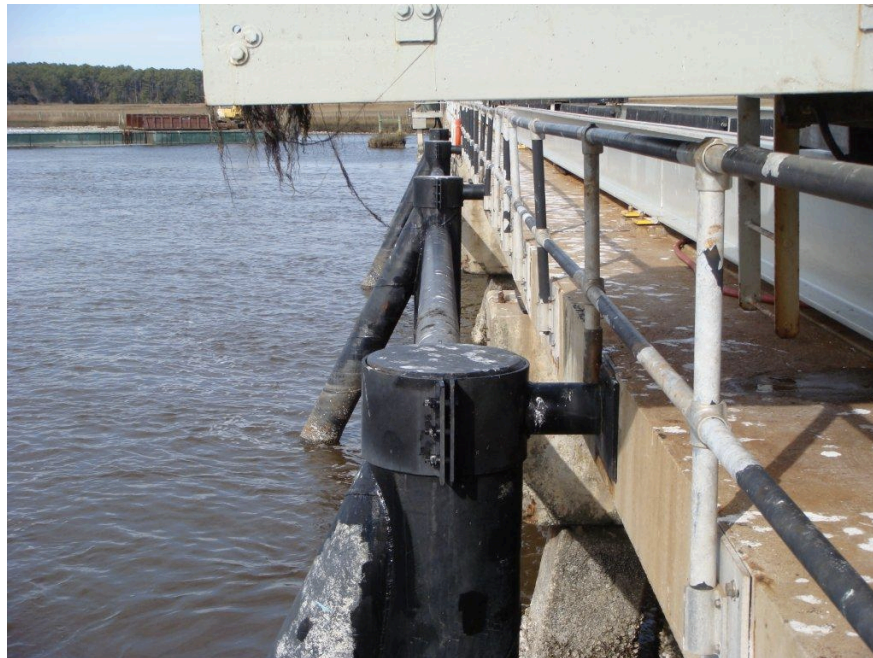
**Figure 6.** A-Frame Assembly

The pile system installed consisted of fifteen 14 X 89# H-Piles on the outside of the structure, battered 3 to 1. These piles were connected to each bent by a pre-fabricated stainless steel plate and pin assembly, which transferred the lateral forces of the structure to the pile, which was in tension. Since the outside piles were in tension, tip elevation was critical in developing pile pull out strength, and therefore penetrating the Limestone and Cemented Sands layer was necessary. On the inside of the structure, nine 20" diameter, 0.500" wall pipe piles were driven vertically adjacent to nine existing pile bents. 16" diameter, 0.500" wall pipe piles were driven at a 3 to 1 batter adjacent to the 20" piles and welded to the vertical piles near the top of the structure to form an A-frame type brace (Figure 6).

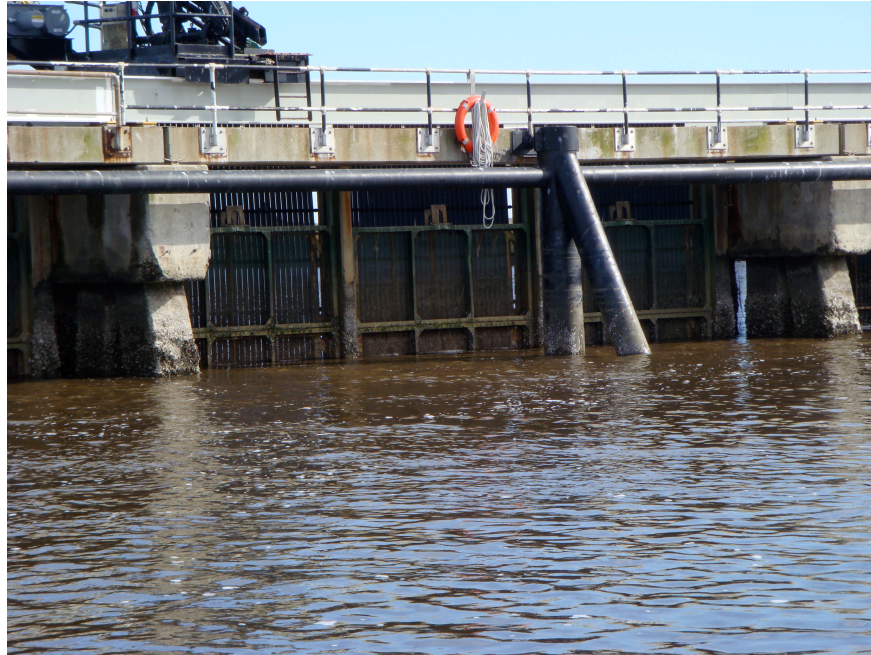
**Figure 7.** 10" Pipe Horizontal Brace

A collar and plate assembly tied each A-frame assembly to its associated existing pile bent. The A-frames were also tied together by welding in a 10" diameter, 0.500" wall pipe pile horizontally just below the elevation of the existing structure deck (Figure 7).

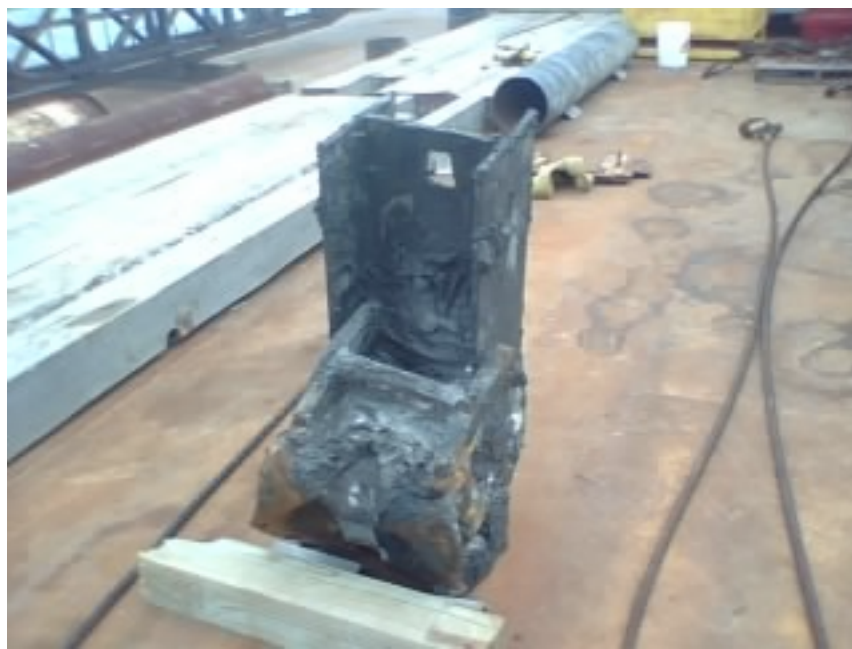
**Figure 8.** Damaged H-Pile

nearly as easily, but finally ‘punched’ through a 3 ft. layer with no damage. The tenth pile was driven to refusal after the tip reached the elevation of the limestone. TBM suspected pile damage based on its prior experience with damaged H-Pile at refusal, and extracted the pile with a vibratory hammer. The pile showed extensive buckling and was repaired (Figure 8).

Several attempts at ‘spudding’ with various reinforced piling were conducted with each attempt resulting in a damaged spud. After several attempts, it was concluded that the thicker limestone was too thick and dense to penetrate via spudding. It was later determined that the limestone varied in thickness from 7 feet to 13 feet throughout the remaining area requiring piles.

***Drilling in a Uniquely Challenging Environment:*** After discussion with the engineer and owner, it was decided that drilling through the limestone and cemented sand layers would be the most effective and only viable method of solving with this problem. Spudding through with a much larger spud was a possibility, but would require much larger and more expensive pile driving equipment, with no guarantee of success since no inside borings were done to determine the layer thicknesses or hardness. This option was high risk with a low probability of success.

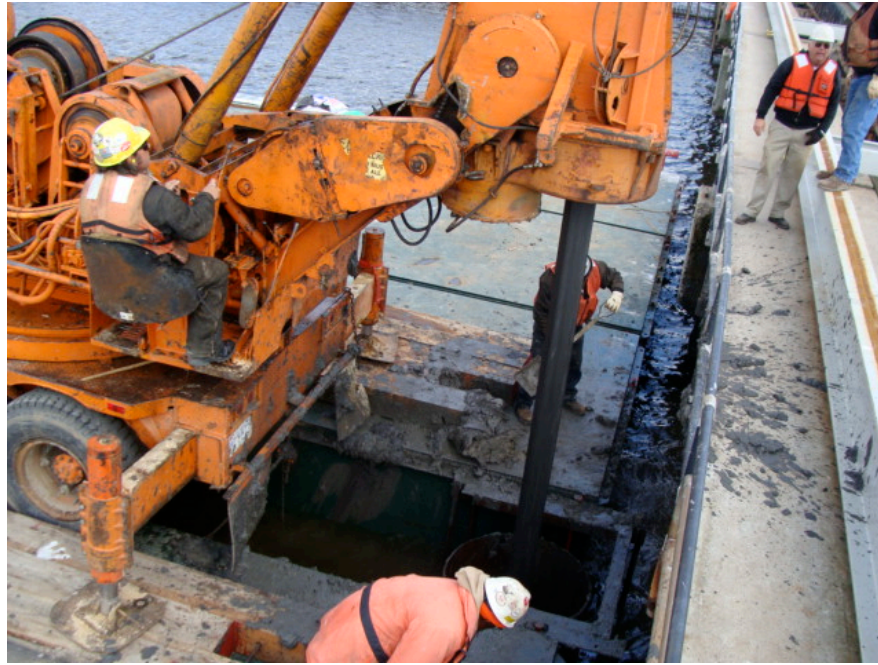
**Figure 10.** Drill Rig on Shugart Barges with Slot

***Mobilizing a Large, Floating Platform Inside of the Structure:*** Mobilizing a floating, truck-mounted drill rig inside of the structure with no way to move a barge inside of the structure was a problem with only one viable solution. Shugart pin-together barges were used to create a 30' x 100' spud barge with a slot located in one end by staggering the pin-together sections by one half a section width (5'). The drill rig straddled this slot so that the holes for the 20" vertical piles and the slots for the 16" batter piles could be drilled without moving the barge (Figure 10). The barge was spudded in place by manipulating the spuds with a crane barge located outside of the

structure. This arrangement ensured that the holes would be lined up perpendicularly to the structure and in the direction of batter. A template for the casing pipe was made that fit inside of the slot and could be easily slid up and down the slot and pinned in place to precisely locate the hole.

The sections of the barge were arranged following the completion of stability calculations to optimize the section layout and minimize barge list and trim. The 28,000 lbs. barge sections were launched at the remote loading site, transported to the structure via the 2.5-mile creek, lifted over the structure and assembled. Once assembled, the barge was moved to the boat ramp inside of the structure, and the drill rig loaded onto it. Once drilling of the holes and slots inside of the structure were complete, the drill rig was off-loaded at the inside boat ramp, driven to the remote loading site, and loaded onto a TBM 30' X 80' spud barge. The barge was transported back to the site via the 2.5-mile creek, and positioned for the outside drilling.

The use of the Shugart pin together barges was innovative, which enabled TBM to mobilize a large barge on the inside of the diversion structure which has no water-borne access.

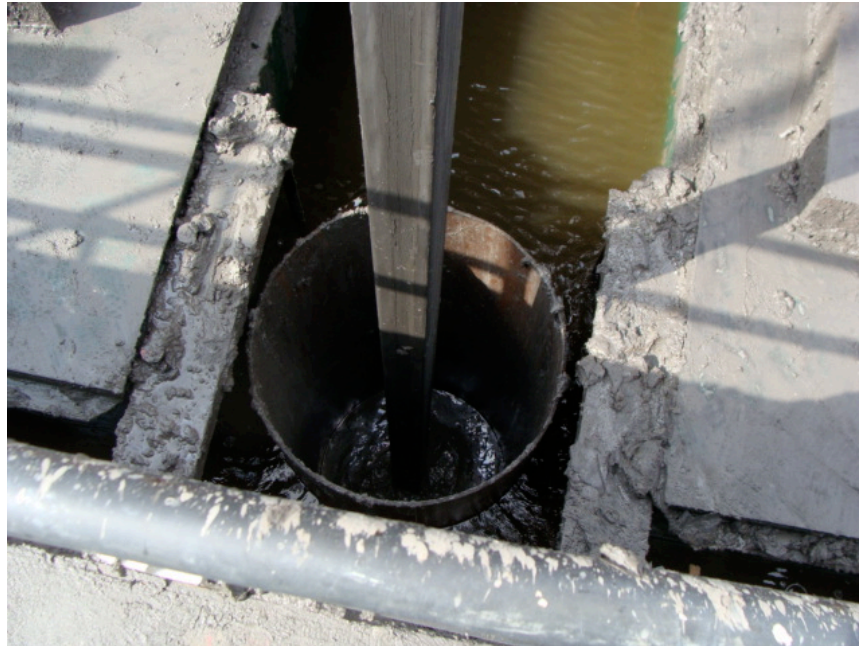
**Figure 11.** Casing Located in Barge Slot

***Precisely Locating Holes to be Drilled:*** The holes would be of no use if they could not be precisely located, drilled, and then located again following removal of the drill rig for job pile placement. In order to precisely locate the hole, and to control drill-generated release, a casing was used (Figure 11).

Fortunately, the elevation of the top of the limestone layer was very consistent, while the bottom (under side of the layer) elevation varied. This facilitated the use of a single length casing pipe. A 42" diameter, 45' long steel casing was driven with a vibratory hammer supported by the outside crane barge, through the silt layer, resting on top of the limestone and cemented sands layer. The drill rig then removed the silt in the casing so that the weight of the silt did not bear on the drill auger, or flow into the cooling water intake. Once the silt was removed from inside the casing, the actual drilling through the limestone commenced. The extreme hardness of the limestone yielded drilling times of 1 to 4 days to completely penetrate the layer. According to the experienced drill team, this material toughness was on par with granite. Before moving the barge and drill rig to follow-on holes, accurate measurements of the hole location were documented to aide in subsequent job pile placement. Once the drill rig was set up on the next hole, the bolt-on template was installed. The template guided each job pile precisely into the hole for the vertical piles, and the slot for the battered piles. Finding the drilled holes, especially the slots, without this precise system of controlling the casing and guiding with the bolt-on template, would have been extremely time consuming if not impossible.

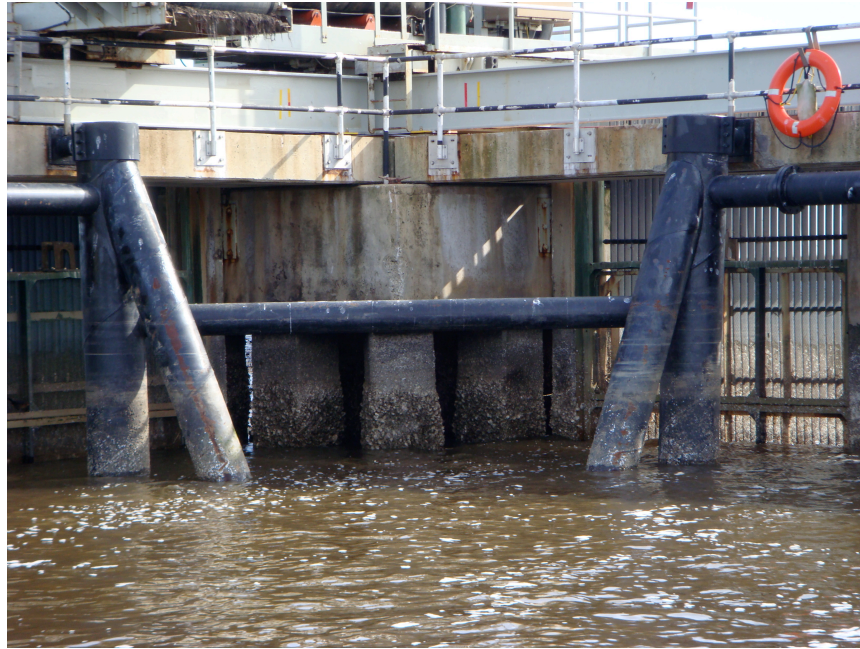
**Figure 12.** Pile Connections to Structure

After all piles were driven, they were fitted and welded to plates bolted to the concrete diversion structure caps using the previously installed studs. The welding work was complicated by the fact that it was over the water and the 16" batter pipe piles had to be fitted and welded precisely to the 20" vertical pipe piles (Figure 12). Once TBM's portion was complete, the owner's contracted divers performed the below water connections from the new pile to the structure.

Also, significant time was saved in fitting the batter pile to vertical pile welds. Steel Fabrication Software, a pipe fitting software application, was used to layout the batter pile to vertical pile cuts for fit up and welding. The angle between each pile was measured using an electronic level, and this was entered into the software along with each pipe diameter. The software generated a table providing plot points along the diameter of the pipe to be cut. These points were manually plotted on a flexible sheet of linoleum. The linoleum was trimmed per the plot, wrapped around the batter pile, and marked. The mark was cut via hand torch, and fitted to the vertical pile. Very little if any trimming was required prior to welding. This application proved to be extremely precise and saved a significant amount of time in cutting and fitting the pipe together.

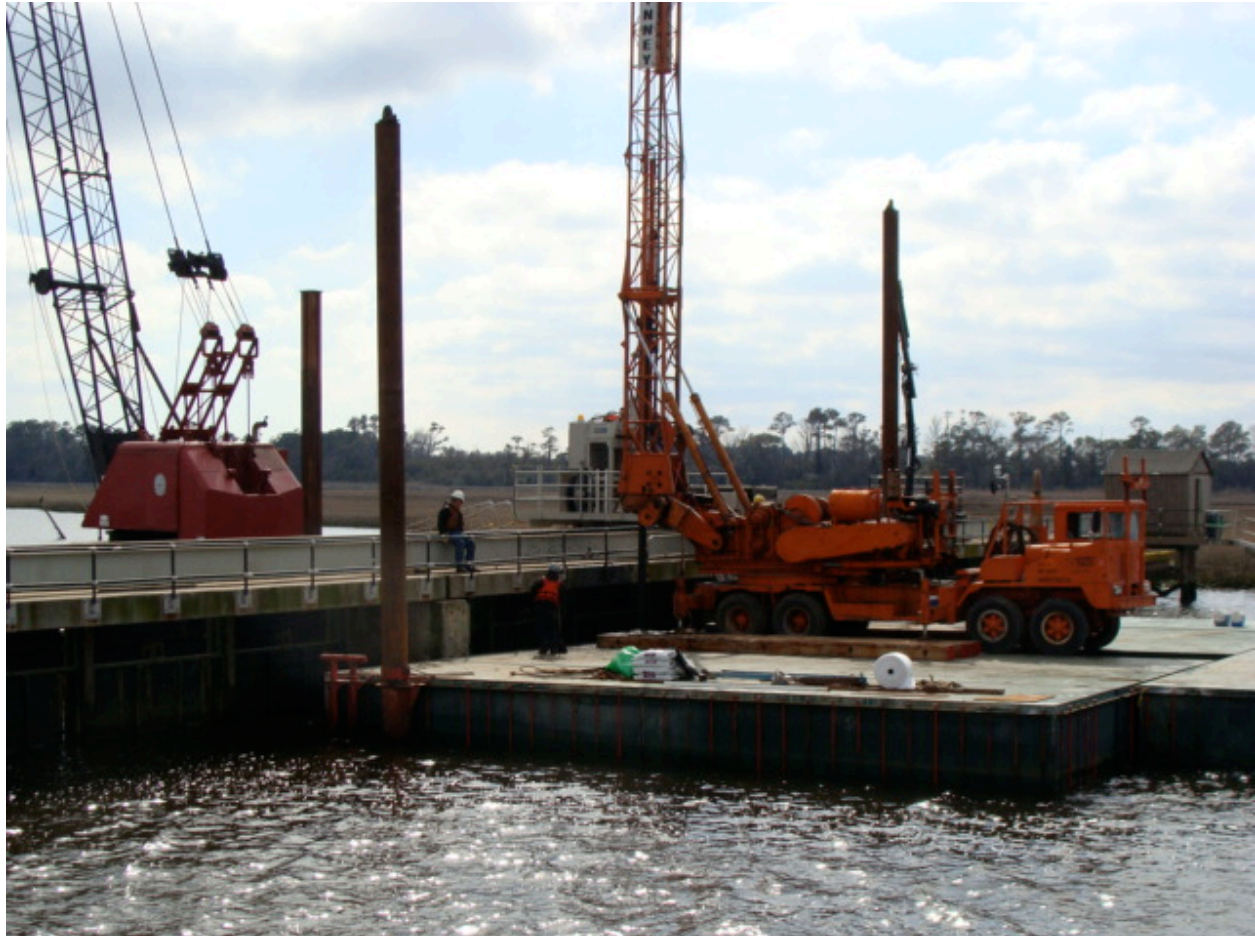
**Figure 13.** Crane Barge Supporting Drill Rig

TBM also mobilized another complete crane barge pile-driving rig and tug boat during the drilling phase to permit pile driving at the drilled sites, while simultaneously supporting the drill rig with the original crane barge. Once a vertical hole and battered slot was complete, the first

crane barge would move the drill rig to the next site and set the casing in place to start drilling (Figure 13). While the casing was being set, the second pile-driving rig would set up and drive the job piles. This saved time by simultaneously drilling and driving job piles to the maximum extent possible. TBM charged no additional mobilization or operating costs to the owner for this equipment.
