**The Morris Island Lighthouse
Phase I Foundation Stabilization Project**

**Submittal for
Pile Buck International, Inc.**

Project Title: Morris Island Lighthouse Foundation Stabilization Phase I

Project Owner: U. S. Army Corps of Engineers

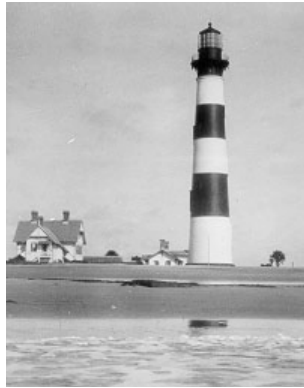
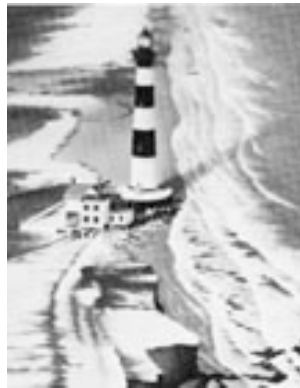
The Morris Island Lighthouse is an iconic, historic structure in Charleston, SC. Since construction of the lighthouse was completed in 1876, it has endured ten (10) hurricanes of Class I or greater, the 1886 Charleston earthquake, and bombing at the end of nearby Folly Beach during World War II. However, construction of jetties at the entrance of Charleston Harbor to improve shipping access from 1878 to 1896 started the erosion of Morris Island. In the 1890's, the lighthouse was approximately 2,700 ft from the shoreline (Figure 1a). By 1938, the shoreline was at the lighthouse (Figure 1b) and the exposure of its foundation to the Atlantic Ocean began.

Figure 1. Selected Morris Island Lighthouse Photographs with Time.

Currently, the lighthouse is approximately 1,600 ft from the shoreline (Figure 1c). Figure 2 presents the shorelines in 1854 and 1979 relative to the lighthouse in plan view. The exposure of the lighthouse foundation to the Atlantic Ocean had severely deteriorated the timber components (i.e. timber piles and timber matting) of the lighthouse foundation, as shown in Figure 3.

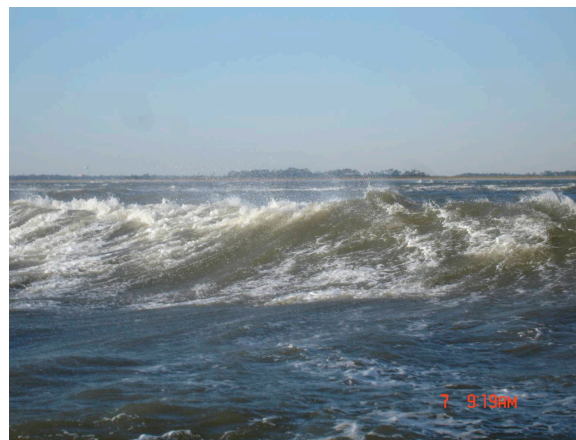
- **Access to the Lighthouse:** Access to the lighthouse is difficult due to changes in tides, which average 6 ft difference between low and high tides, waves, wind conditions, and the deposition of sand bars around the lighthouse. Figure 5 shows typical wave conditions around the Morris Island Lighthouse.

Figure 5. Typical wave conditions at Morris Island Lighthouse.

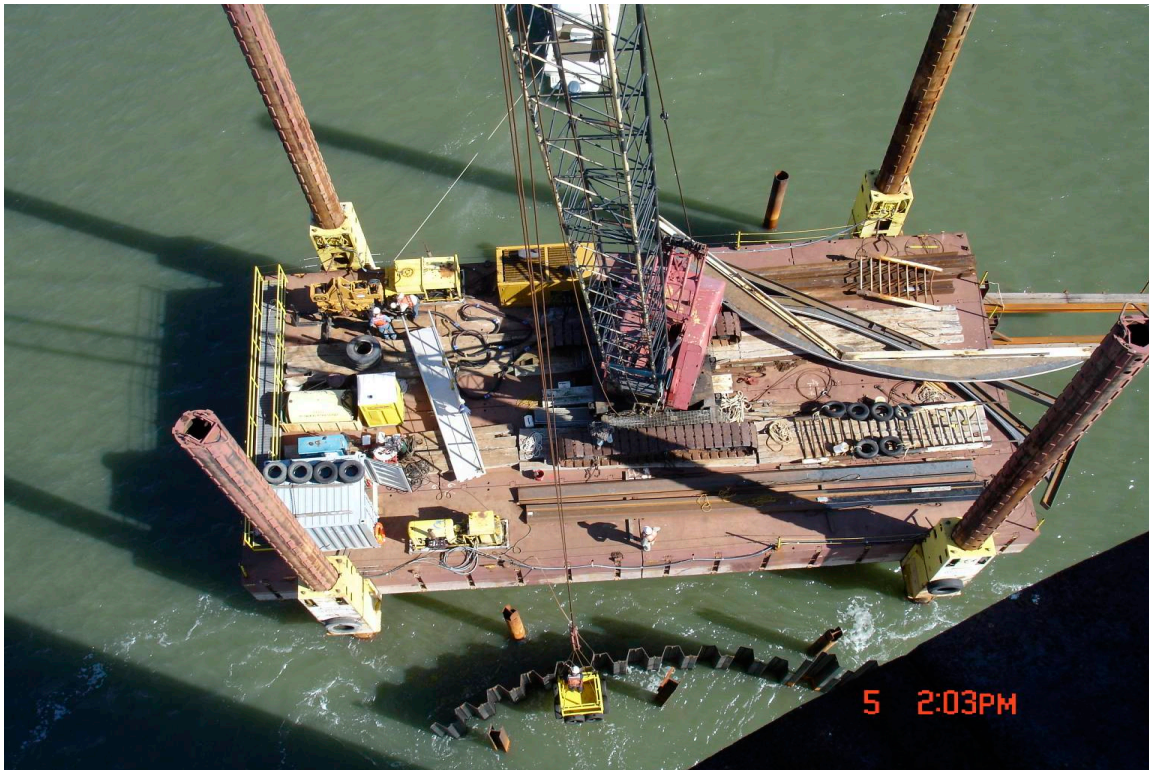
A jack-up barge was selected for use to overcome the tide and wave challenges and provided a steady crane and work platform for the installation of the PZ-40 sheeting and associated HP piling for the template. The jack-up barge is presented relative to the lighthouse in Figure 6. Accessing the jack-up barge via small boat, and moving the jack-up barge still remained problematic during high sea days.

Figure 6. Jack-up Barge at Morris Island Lighthouse (taken from top of Lighthouse).

Access to the Lighthouse: Solved by the use of a jack-up barge.

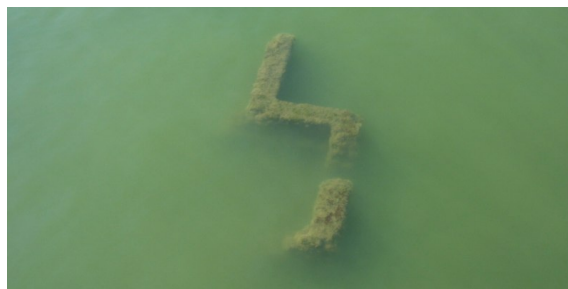
- **Buried Obstacles:** Remnants of the old lighthouse building foundations, walls, and portions of the 1939 repair were located around the structure. All of this debris was located below Mean Low Tide, with a substantial portion below the existing mud line. Figure 7 shows a foundation from the old light keepers residence visible at low tide.

Figure 7. Existing Debris around Lighthouse.

While some of the debris could be located at low tide, the exact location of the majority of these obstacles was unknown. The debris around the lighthouse prevented the installation of several PZ-40 sheet piles to the required embedment with the originally selected vibratory hammer (an APE Model 50). An extensive pile-probing program, consisting of driving and removing HP piles concentrically around the lighthouse, was implemented to determine the extent of the debris field around the lighthouse. The results of this pile-probing program are presented in Figure 8. After an extensive evaluation of different options, such as removal of the debris and expansion or contraction of the sheet pile cofferdam, the decision was made to increase the size of the vibratory hammer to an APE Model 150 and utilize a gravity drop hammer on stubborn piles and "punch" through the debris. This option was successfully implemented. The APE Model 150 performed very well, and the drop hammer was used on about 20 extra stubborn locations. Additional details of the various option evaluations are presented in the **Cost Saving Measures** section of this submittal.

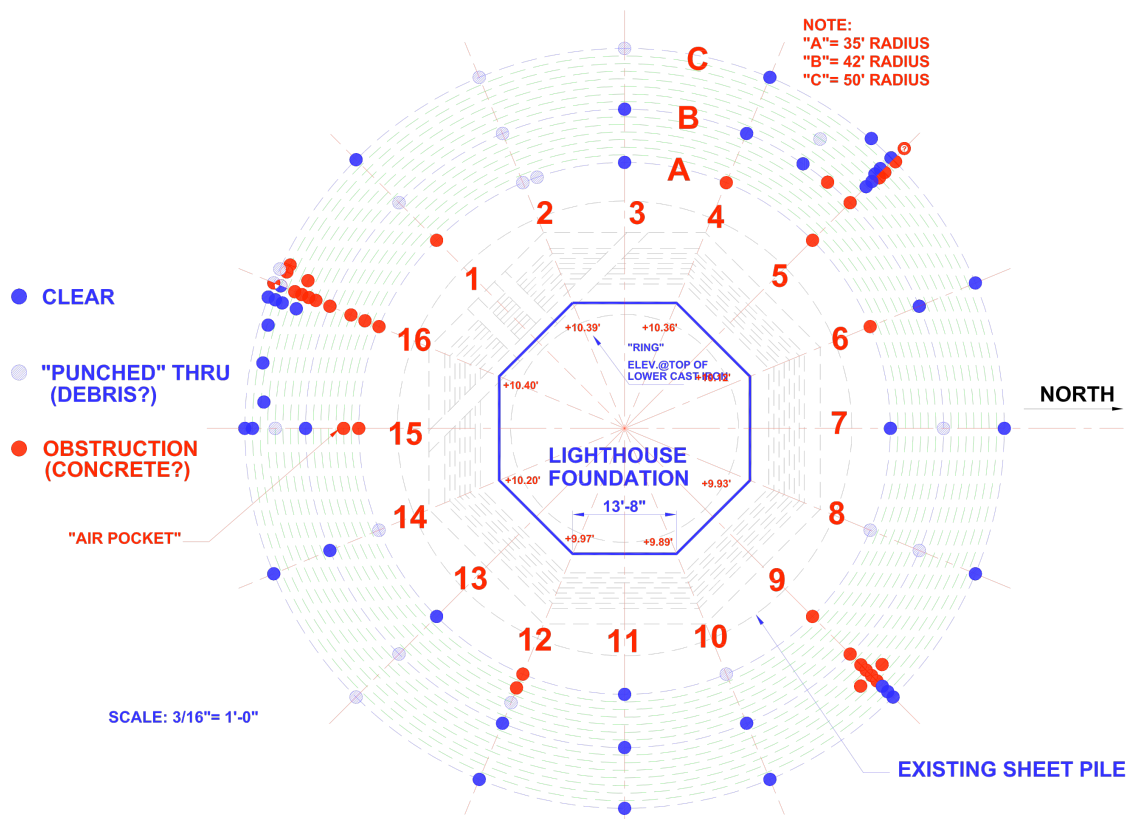
Figure 8. Pile Probing Program Results.

- ☐ **Larger Diameter Cofferdam Wall.** This option would significantly increase project costs from additional sheeting and installation and still would encounter debris (as shown in the probing plan in Figure 8. In addition, the project timeframe would have to be increased.
- ☐ **Shorter Diameter Cofferdam Wall.** This option would place the PZ-40 sheet piling next to the 1939 repair sheet piling. While this would reduce the number of sheets and therefore project costs, the engineering analysis showed that the remnants of the 1939 sheet piling were most likely significantly assisting in supporting the lighthouse compromised foundation. Therefore, it was decided to not potentially jeopardize the lighthouse by decreasing the cofferdam diameter.

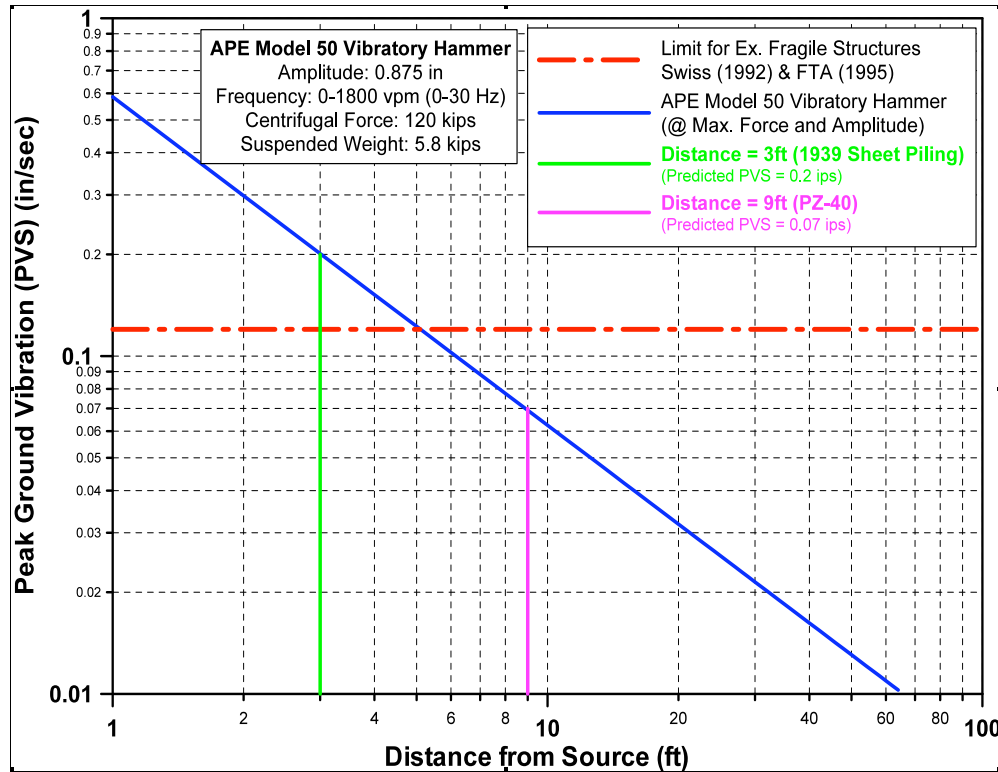
Potential Damage to a Historic Structure: Solved by conducting an exhaustive analysis of the structure and the effects of potential ground vibrations generated during the piling installations. The data from the PDCA Driven Pile Case History Database was used in this analysis. Figure 12 presents the predicted vibrations with distance for the APE Model 50 vibratory hammer. Also presented in Figure 12 are various vibration criteria, the distance from the new PZ-40 sheet piling to the old 1939 sheet piling, and the distance from the new PZ-40 sheet piling to the lighthouse foundation.

Figure 12. Predicted vibrations from APE Model 50 Vibratory Hammer (developed using PDCA Driven Pile Case History Database).

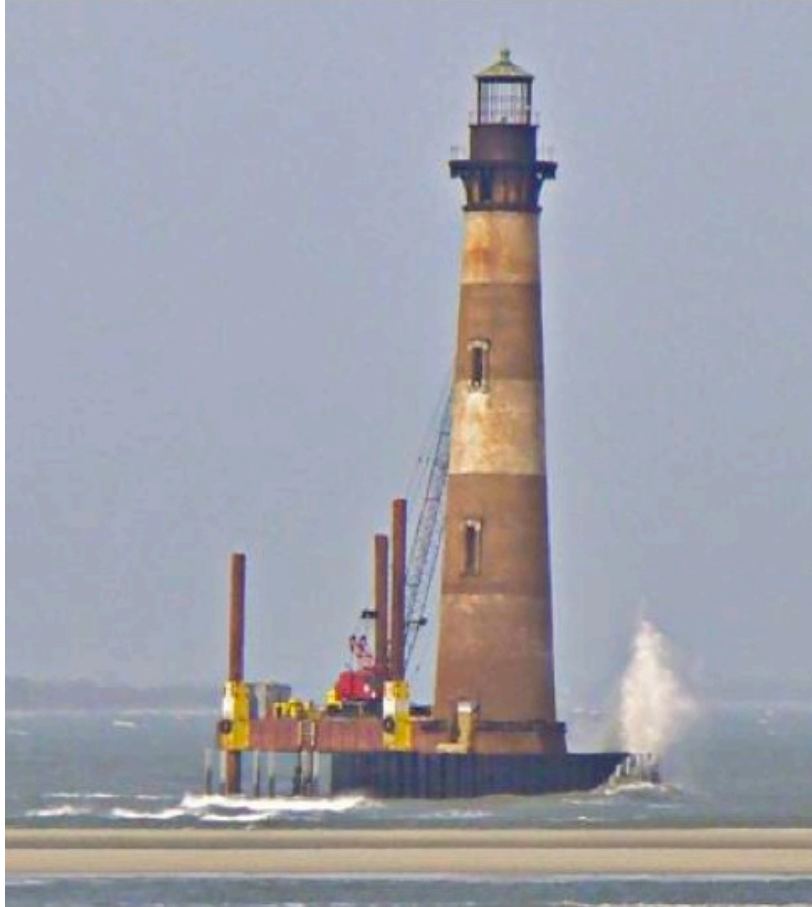
As shown in the structure monitoring data over the course of the project, ***the installation of the sheet pile cofferdam provided immediate protection to the lighthouse.*** In addition, the installation of the PZ-40 sheeting, associated template piling, and various dock piling did not damage the structure. This was verified by the post-condition survey, which showed no significant damage to historic lighthouse occurred during the project. An example of the protection provided is presented in Figure 13, which shows a wave breaking on the sheet pile cofferdam.

Figure 13. Waves breaking over the Morris Island Lighthouse Sheet Pile Cofferdam.
Driven Piles Protecting the Past, Helping Preserve the Future.
