**TAYLOR BROS. MARINE
CONSTRUCTION, INC.**

**Hull Repairs for USS North Carolina Battleship
Project
Submittal for the
The Pinnacle Awards
2011 Best Construction Project Competition**

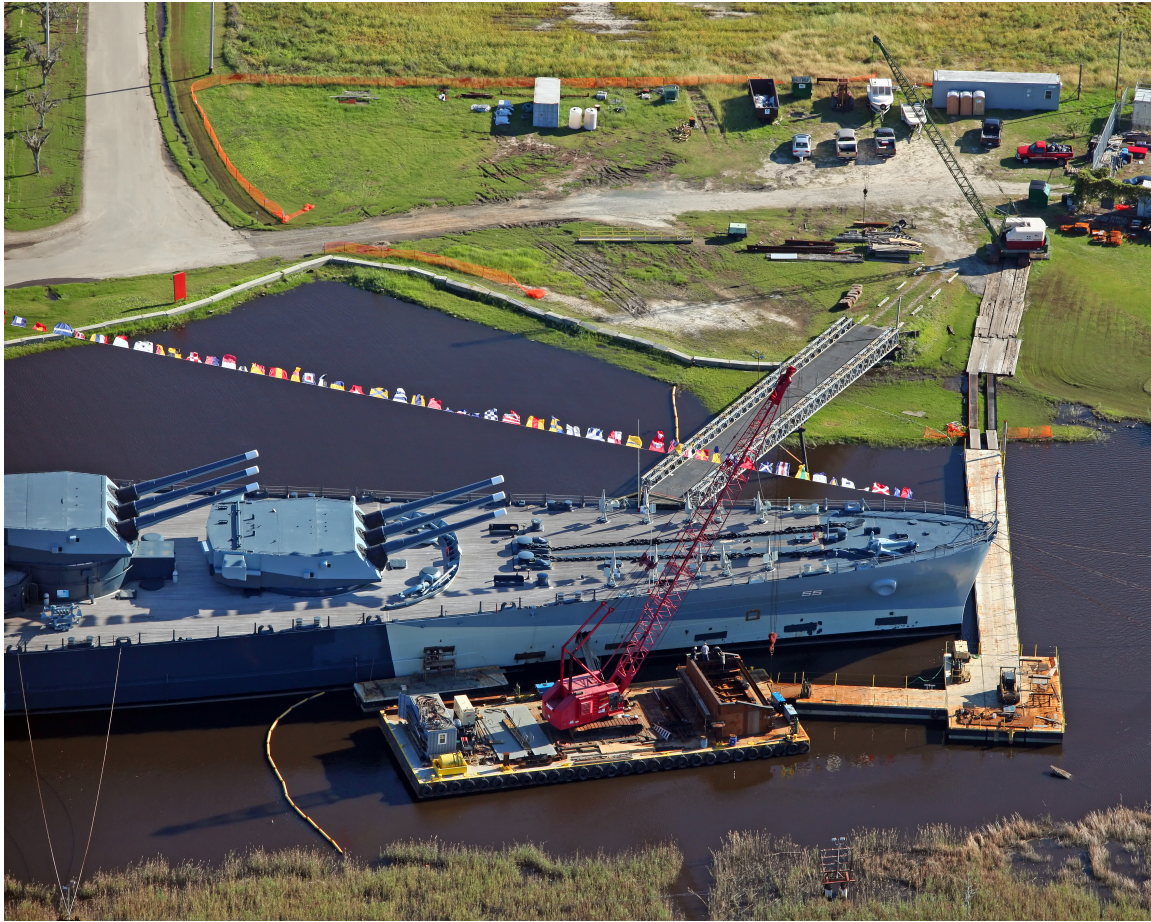
Figure 3. Site Plan

The work site was the starboard (right hand when facing forward on the ship) side of the bow. We were tasked with cutting out and replacing 132 feet of hull plating, 10 feet tall, at and below the waterline. Some of the hull cutting was directly into Nr. 6 oil (Bunker C) tanks, so those tanks required cleaning. Accessing the site was a challenge. Fuel tank cleaning hoses and transporting material across the teak deck of the ship was problematic in that it posed a safety threat to visitors unless the bow was completely secured, and it threatened damage to the beautiful teak deck of the ship. Since the bow is such an important part of the tour route, Taylor Bros. Marine created a floating bridge from the shore on the port side of the ship, out and around the bow, to the work site. This bridge was made of Taylor Bros. Marine sectional barges spudded (anchored to the bottom using long, heavy pipes attached to the sides of the barge) at each end. This bridge provided a secure place to tie down all tank cleaning and lead base paint remediation hoses, while provided a safe platform to access the site. Steel plate could also be transported directly to the site using a small fork lift. Hand rails were placed along each side of the bridge for

personnel safety. It also allowed the crew to park vehicles out of the way, and walk to the site without interfering with the ship operations or visitors. This system proved to be very efficient and saved countless days accessing the work site. See Figure 3, Site Plan.

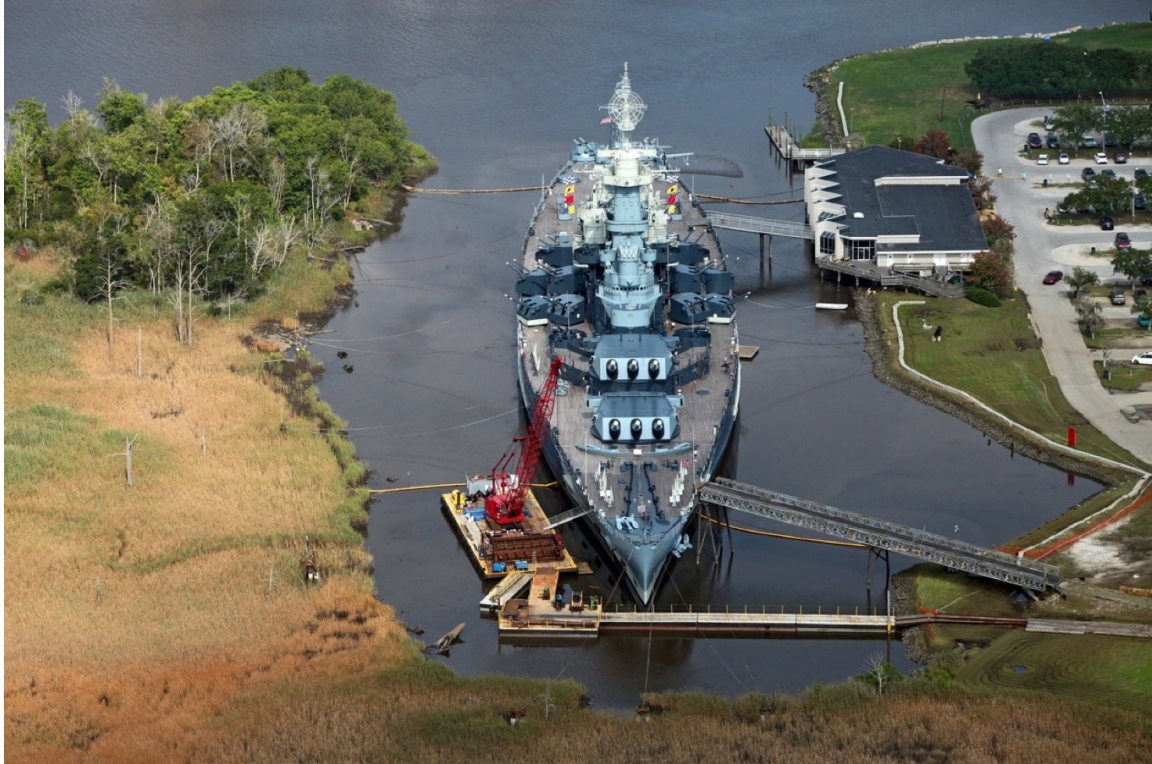
Figure 15. Pinnacle Award Project

It was the privilege of a lifetime to be selected to conduct repairs on this piece of history, and the project was a huge success for our company, the ship, the community, and the nation. See Figure 15, Pinnacle Award Project. This project is most deserving of the Pinnacle Award for Best Building Project.
